Reynolds Conditions Assessment

The conditions assessment was completed by Travis Rose and Master of Historic Preservation student: Jack Galle.
Material conservation assessments were completed by the Fall 2022 students of HP 252.

From August to December of 2022, a conservation conditions assessment was completed for the Reynolds Building. The task was to document the building's condition prior to a major rehabilitation of the building. Students were instructed to identify maintenance needs, instances of unusual wear or deterioration and provide conservation recommendations of historic structural systems, and important architectural features as needed. The Reynolds Building was documented, material conditions were assessed, and critical deterioration was recorded; important structural systems and character-defining elements were analyzed in detail. Building condition assessments were recorded in a spreadsheet, with accompanied floorplans to identify deterioration locations.¹

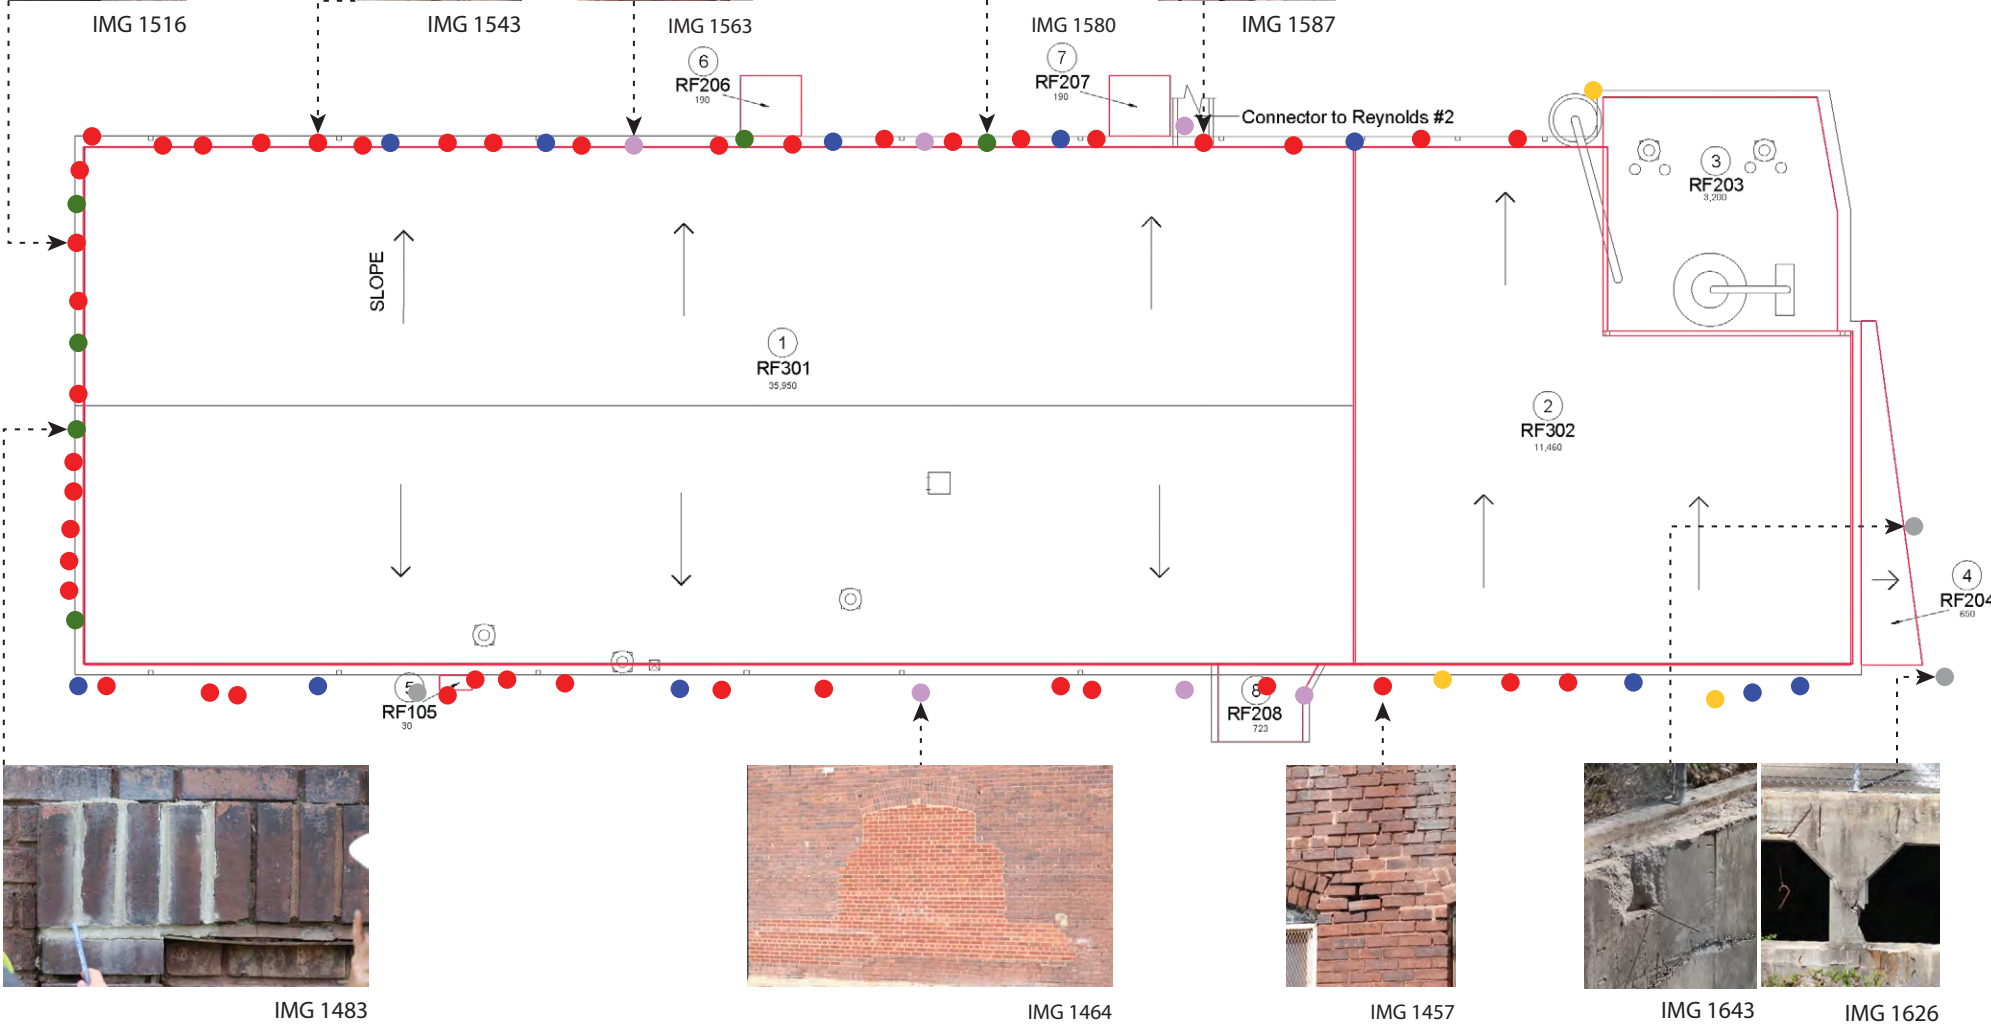
BASEMENT FLOOR PLAN

mortar
cracking

concrete
cracking

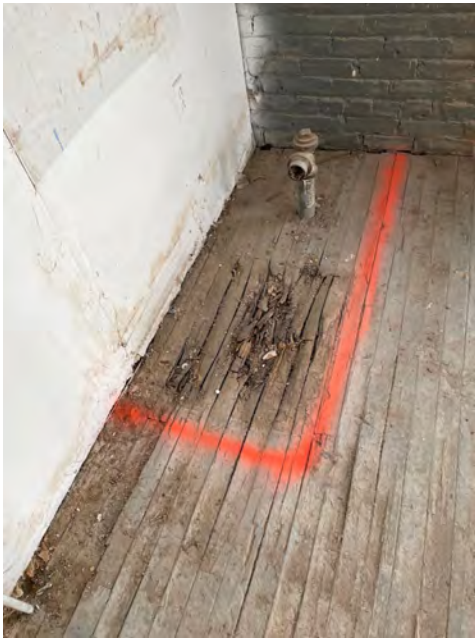
Cracks/Fractures

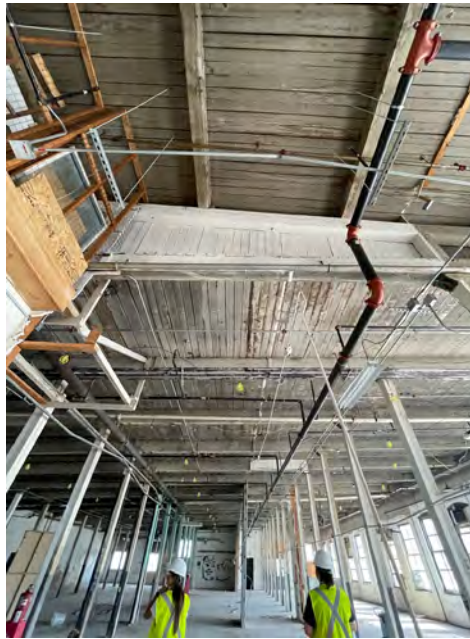
Water Damage & Chipping

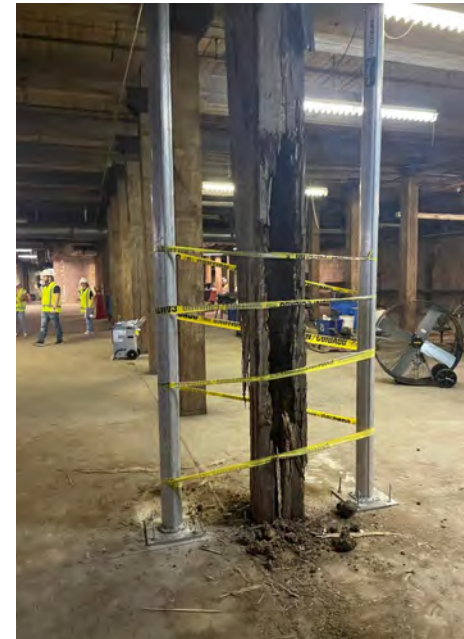
Eaten By Insects

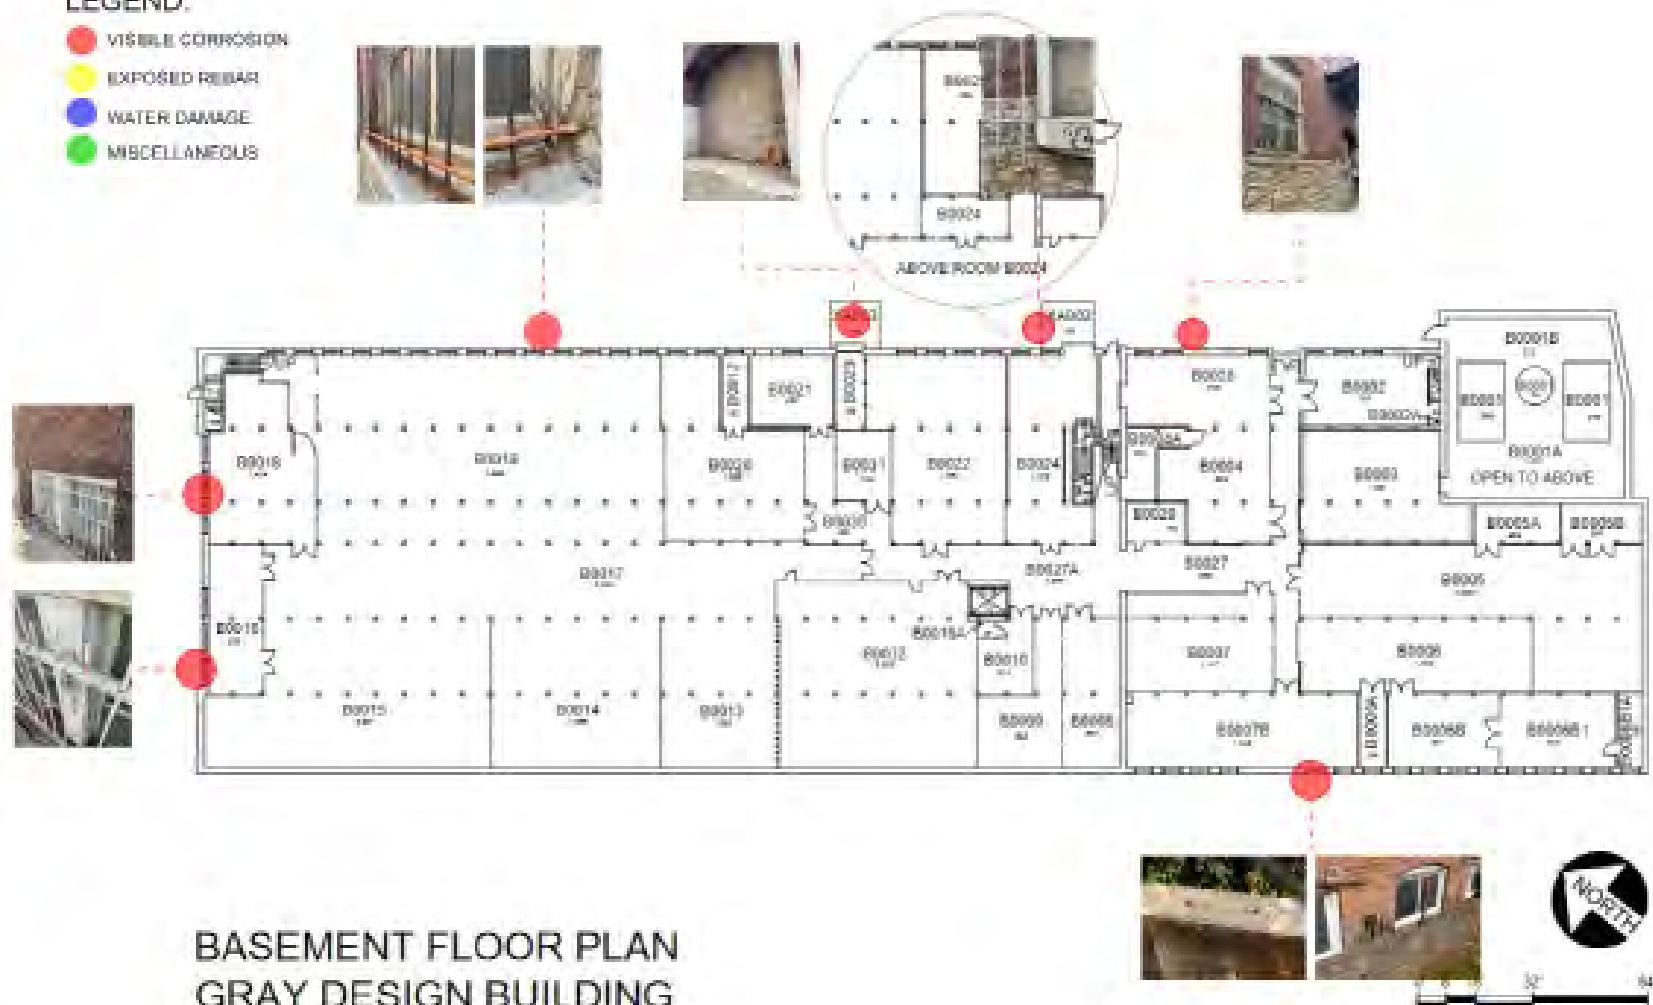
**BASEMENT FLOOR PLAN
GRAY DESIGN BUILDING**

- VISIBLE CORROSION
- EXPOSED REBAR
- WATER DAMAGE
- MISCELLANEOUS

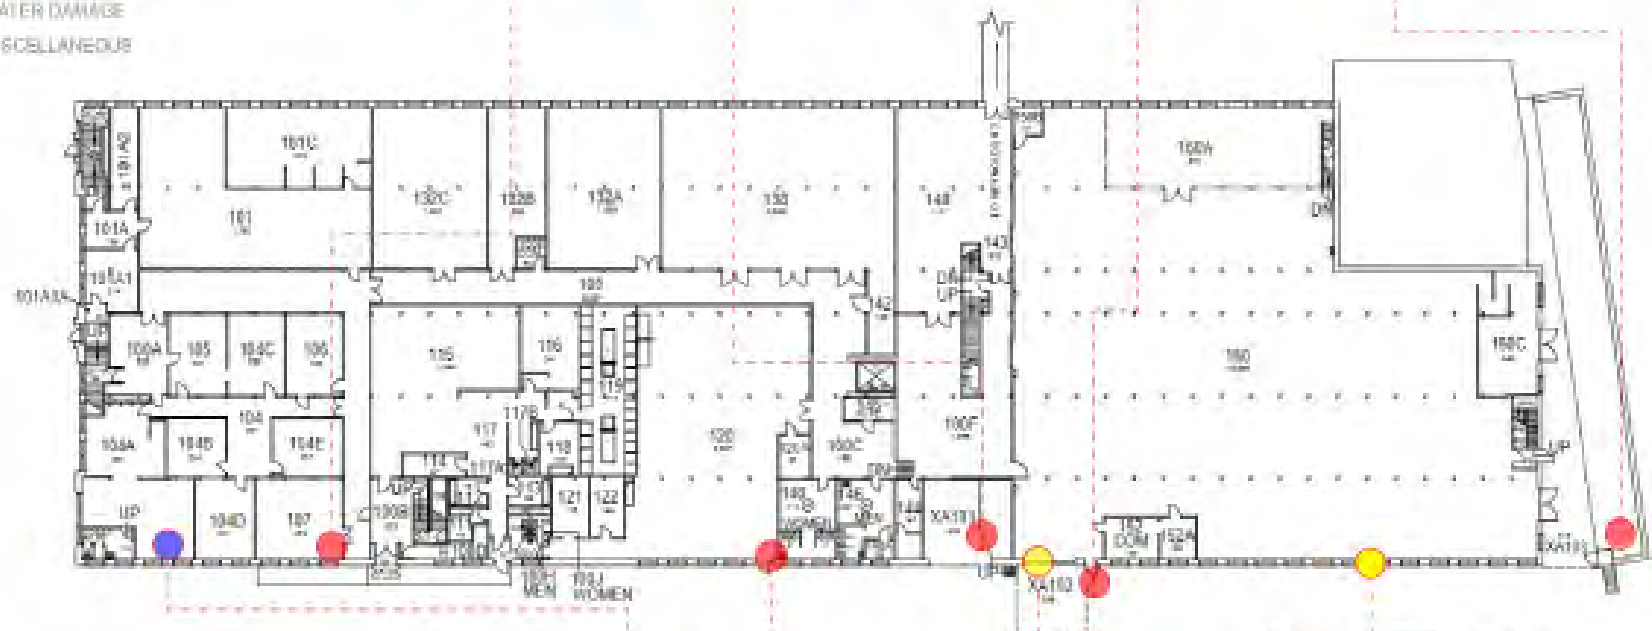
FIRST FLOOR PLAN GRAY DESIGN BUILDING

- VISIBLE CORROSION
- EXPOSED REBAR
- WATER DAMAGE
- MISCELLANEOUS

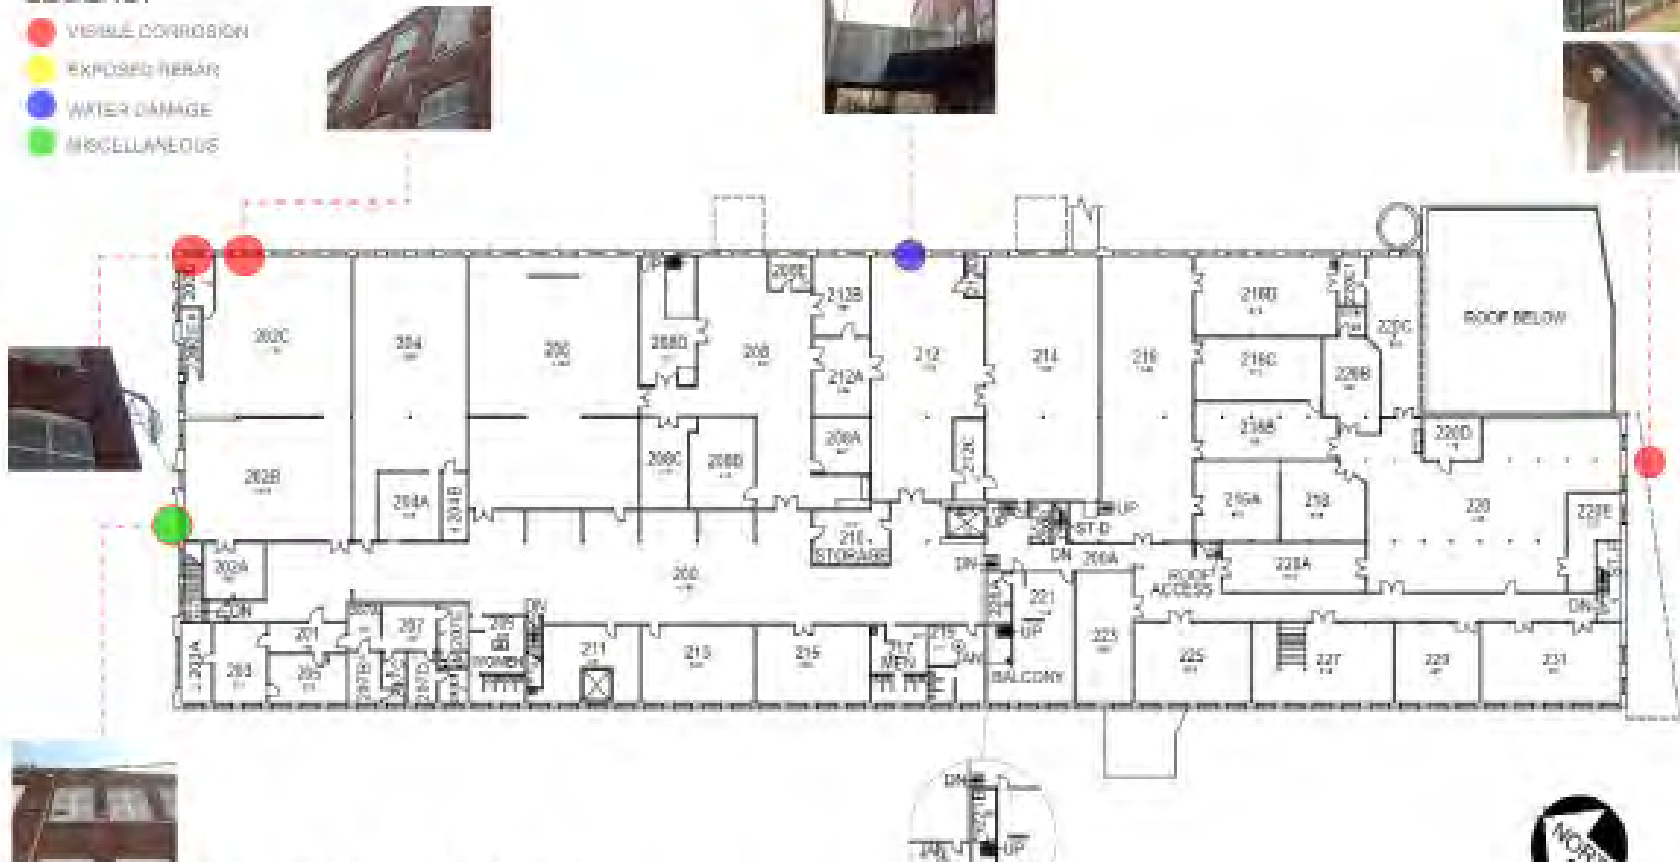
SECOND FLOOR PLAN GRAY DESIGN BUILDING

- VISIBLE CORROSION
- EXPOSED REBAR
- WATER DAMAGE
- MISCELLANEOUS

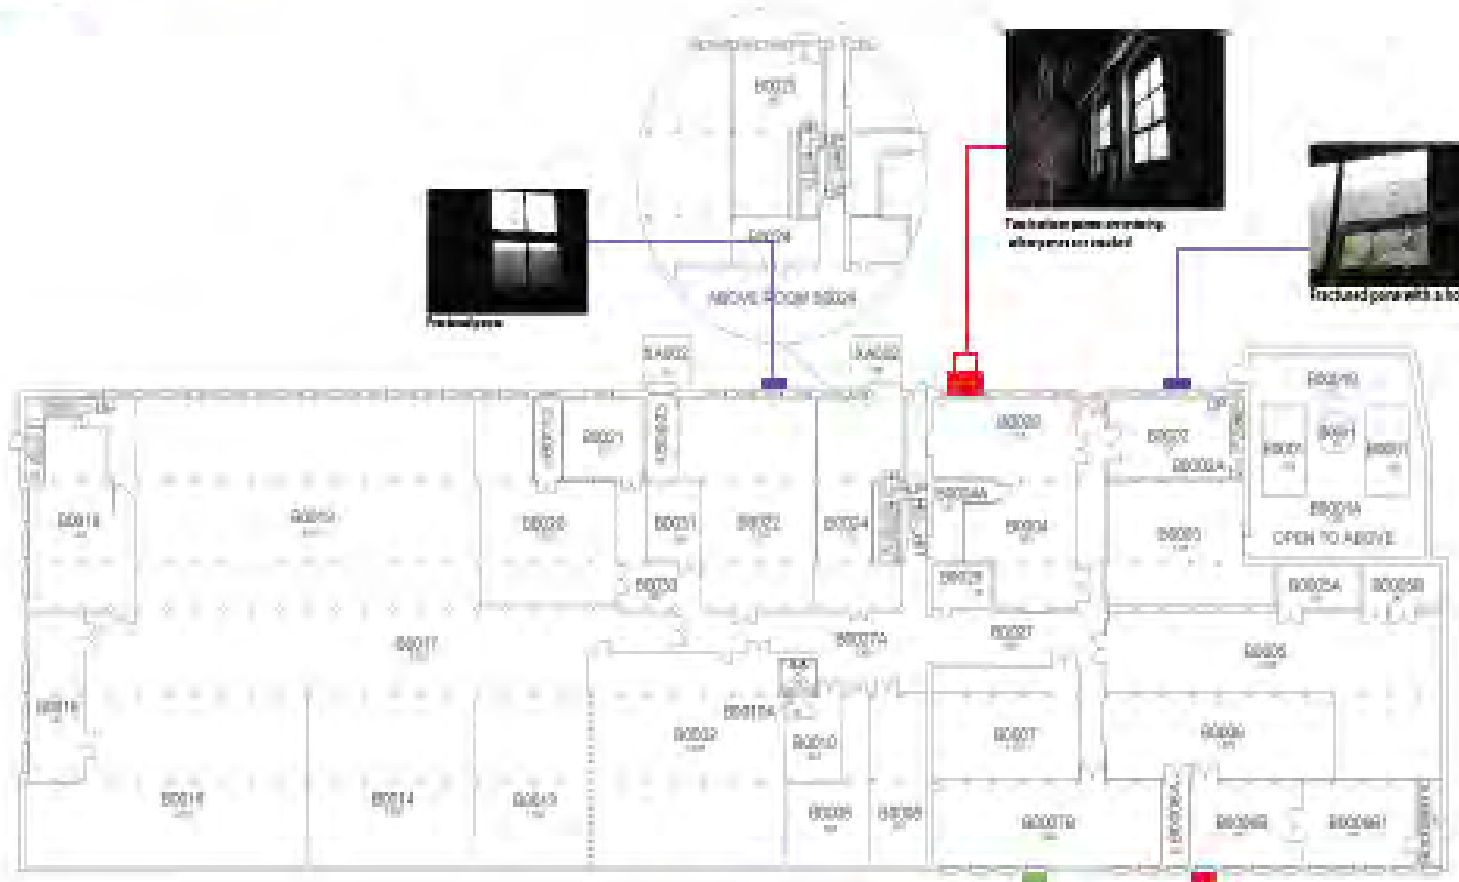
Shattered glass
