**Reynolds Building**  
**Historical Analysis and Inventory of Significant Features**

June 2019

Prepared by  
Daniel Vivian  
Department of Historic Preservation  
University of Kentucky  
Lexington, KY 40506  
(859) 323-6392 / [daniel.vivian@uky.edu](mailto:daniel.vivian@uky.edu)

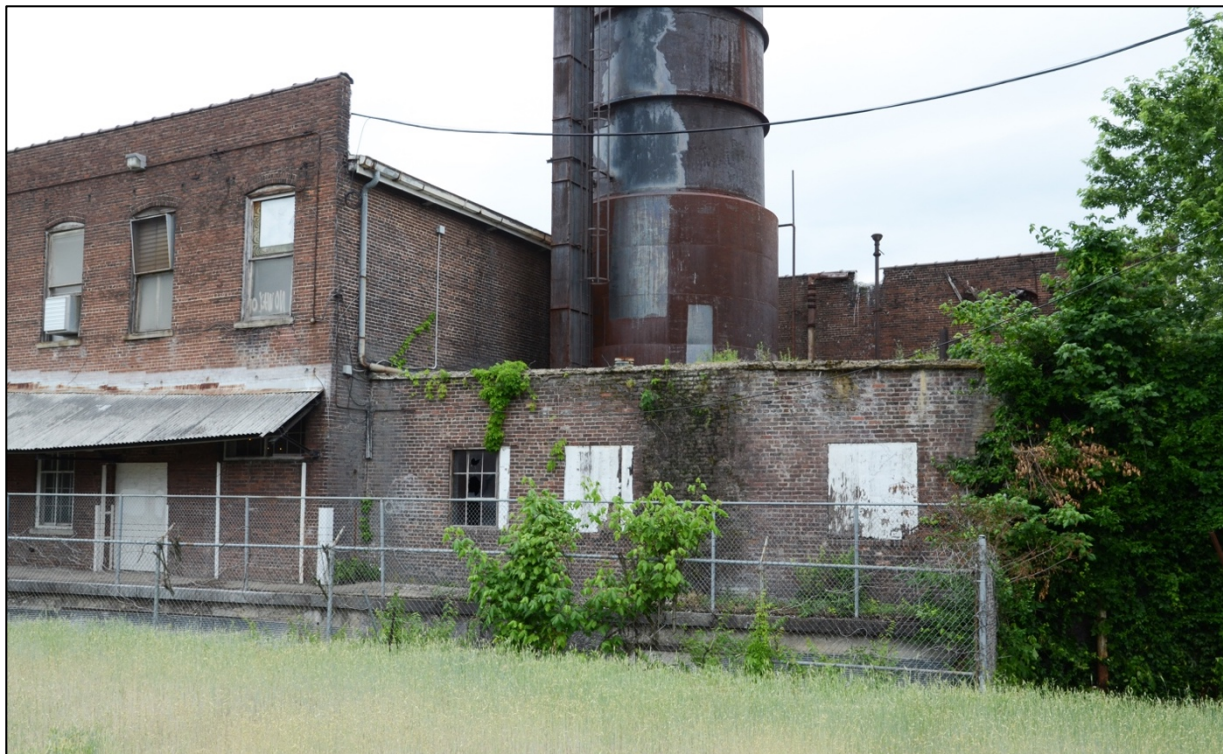
Figure 3. Rear of building, showing relationship between warehouse section (left) and power plant (right).

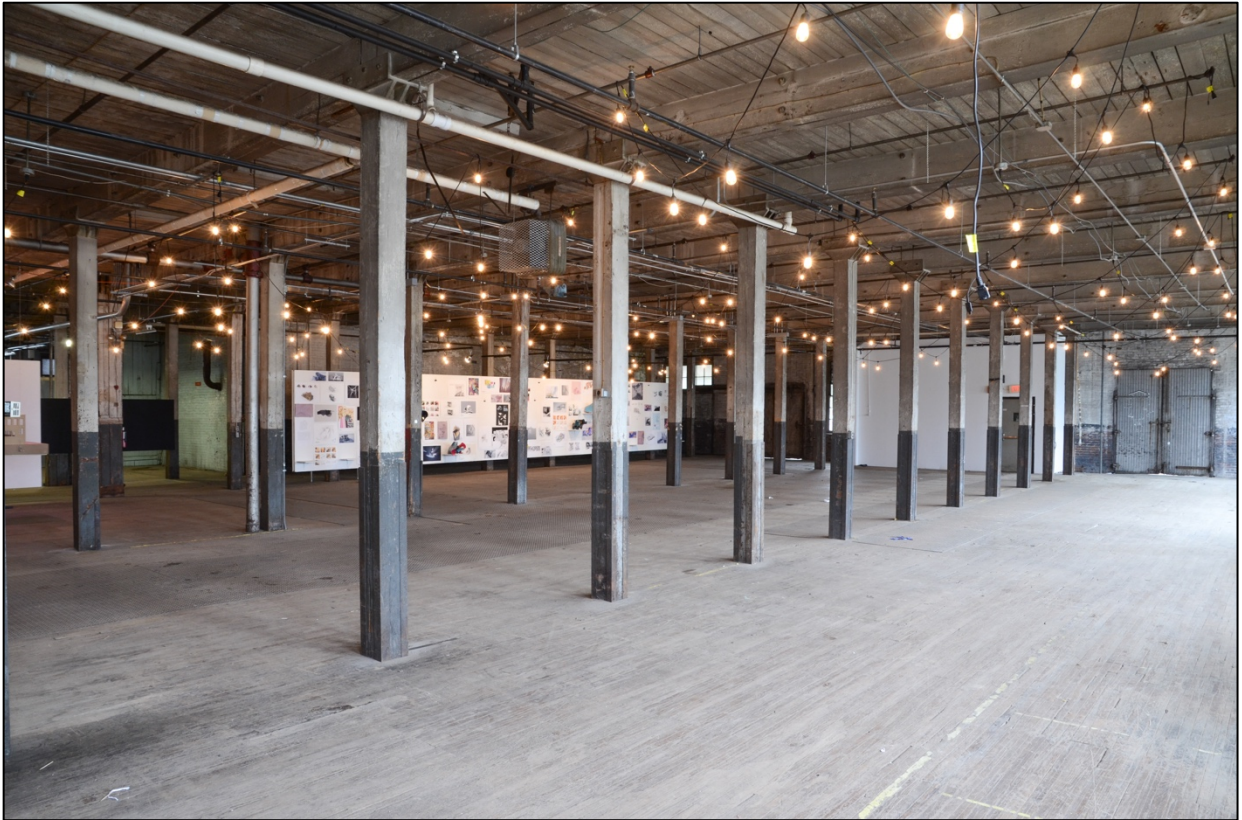
Figure 4. Former hogshead storage, warehouse section.

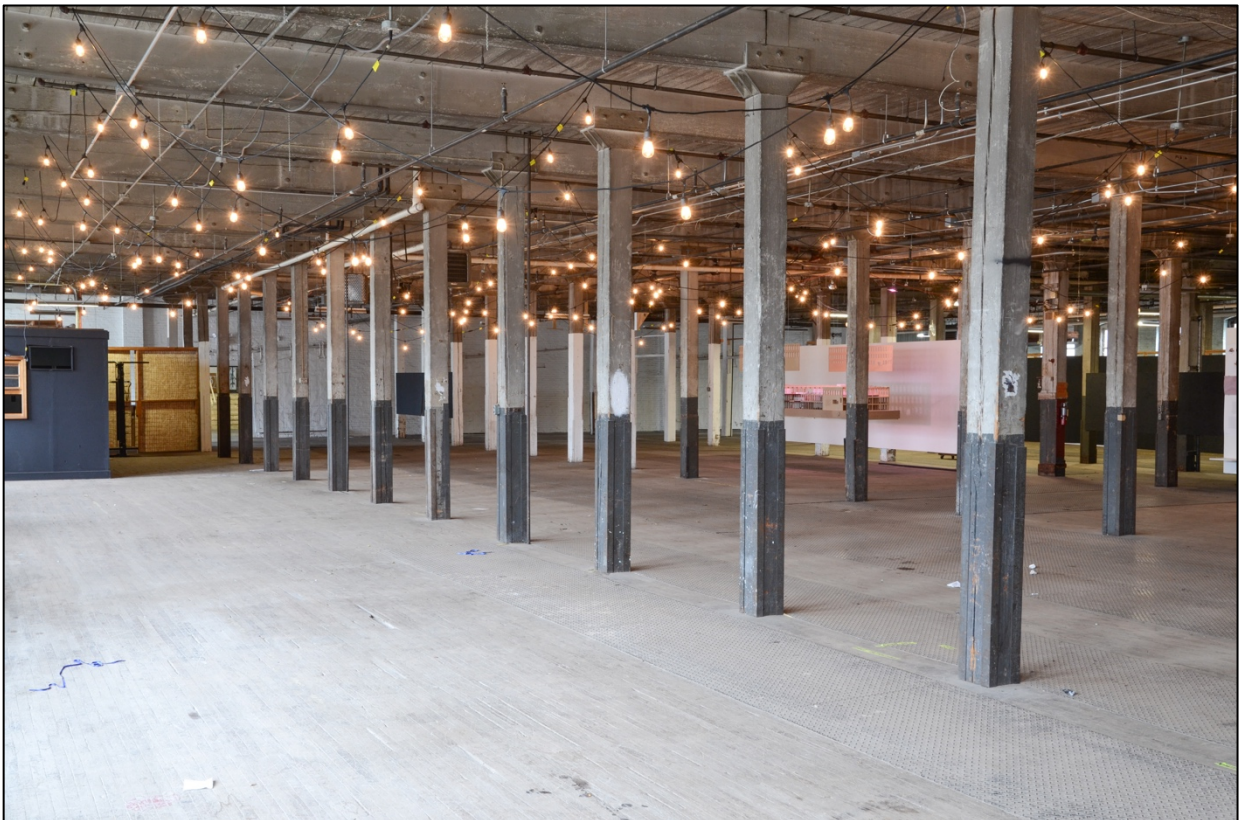
Figure 5. Former hogshead storage, warehouse section.

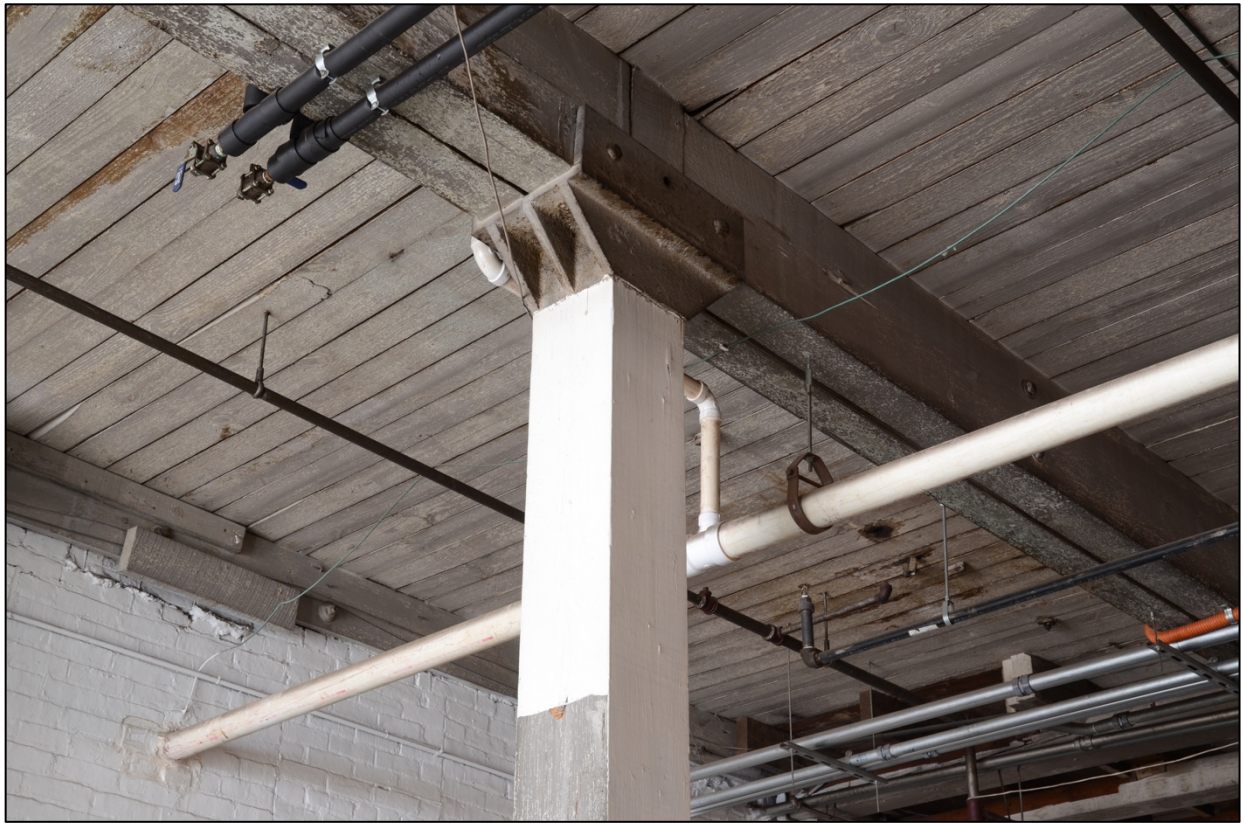
Figure 6. Heavy timber truss and bracket, warehouse section.

- Open interior volumes on all floors should be retained to the greatest extent possible, with wood columns and trusses left exposed. Where partitions are needed, they should be installed so that large expanses of space are left to appreciate the structure of the building, the scale of the interior volumes, and the visual rhythm created by the rows of vertical timber supports.

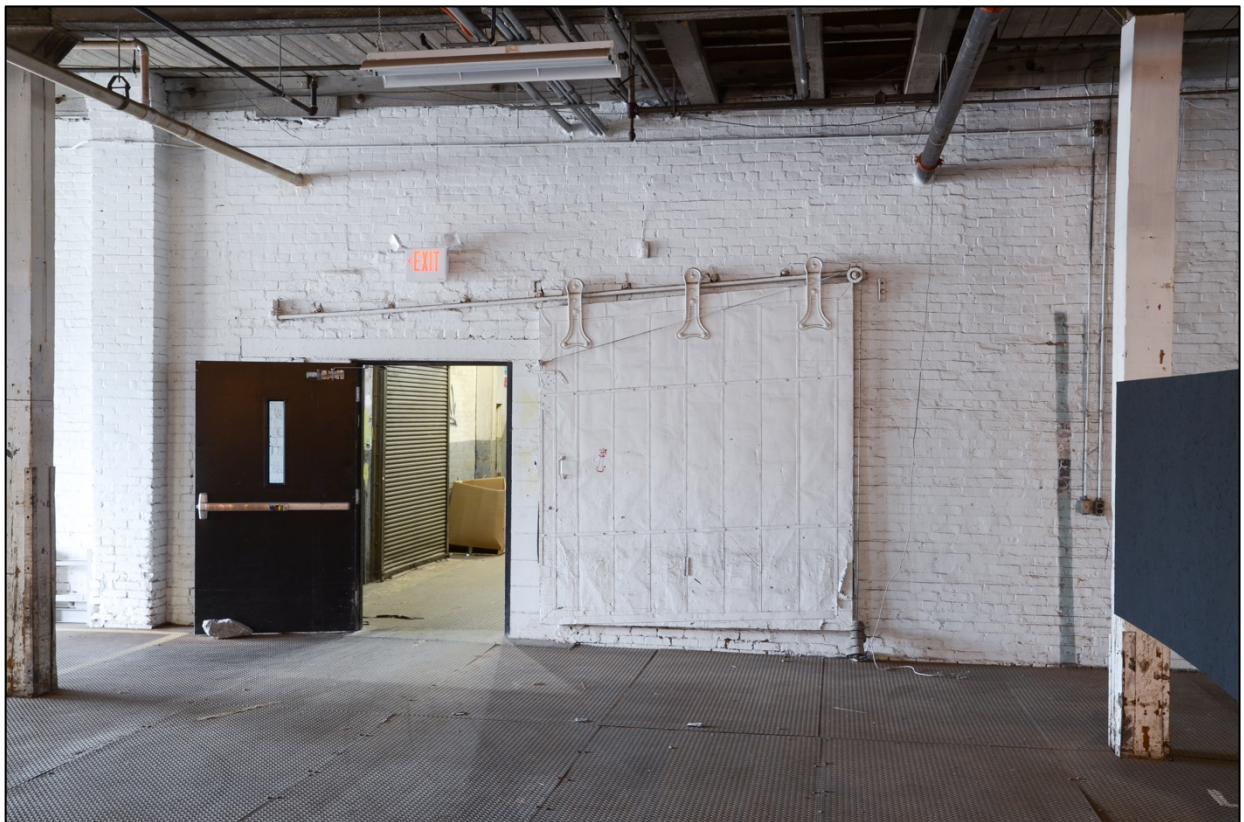
Figure 7. Sliding fire door, first floor, warehouse section.

- The sliding firewalls on the first floor immediately inside the loading dock facing Scott Street and in the basement immediately below should be refinished and retained.

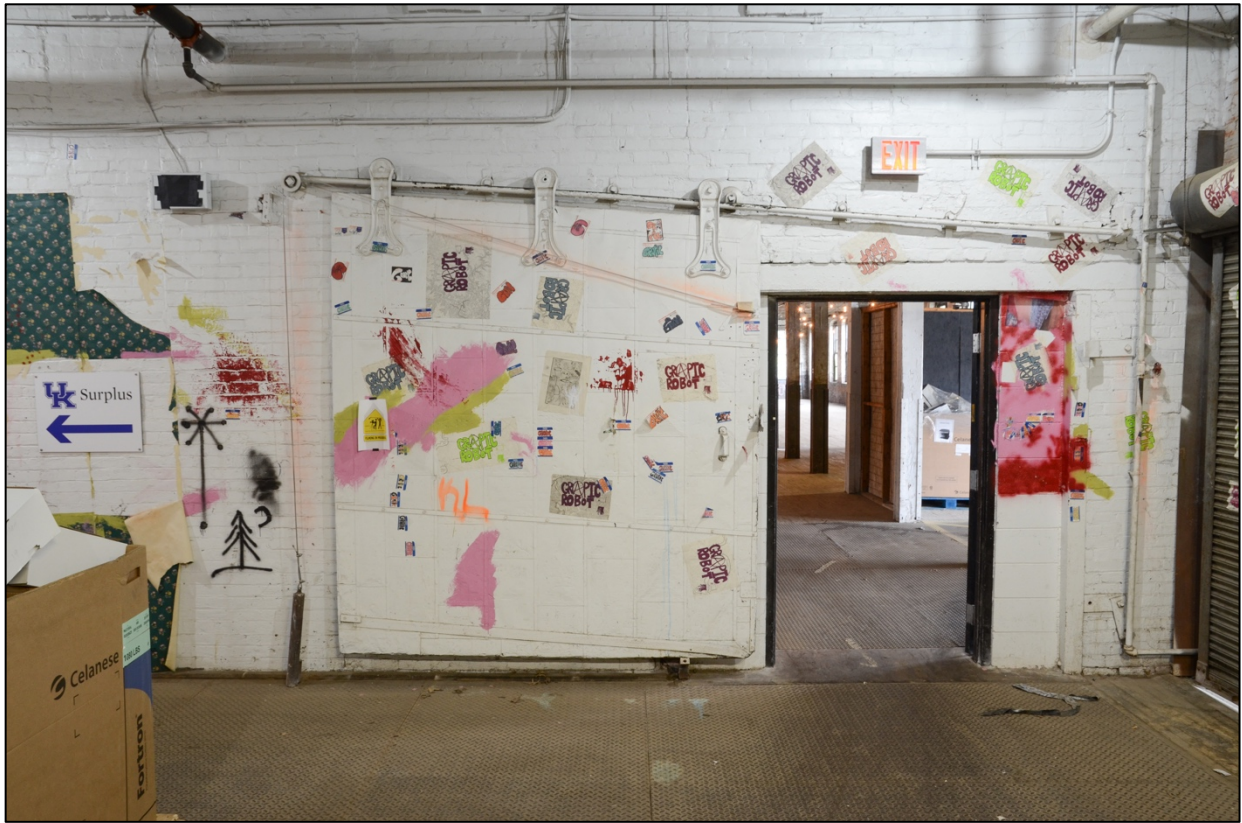
Figure 8. Sliding fire door, first floor.

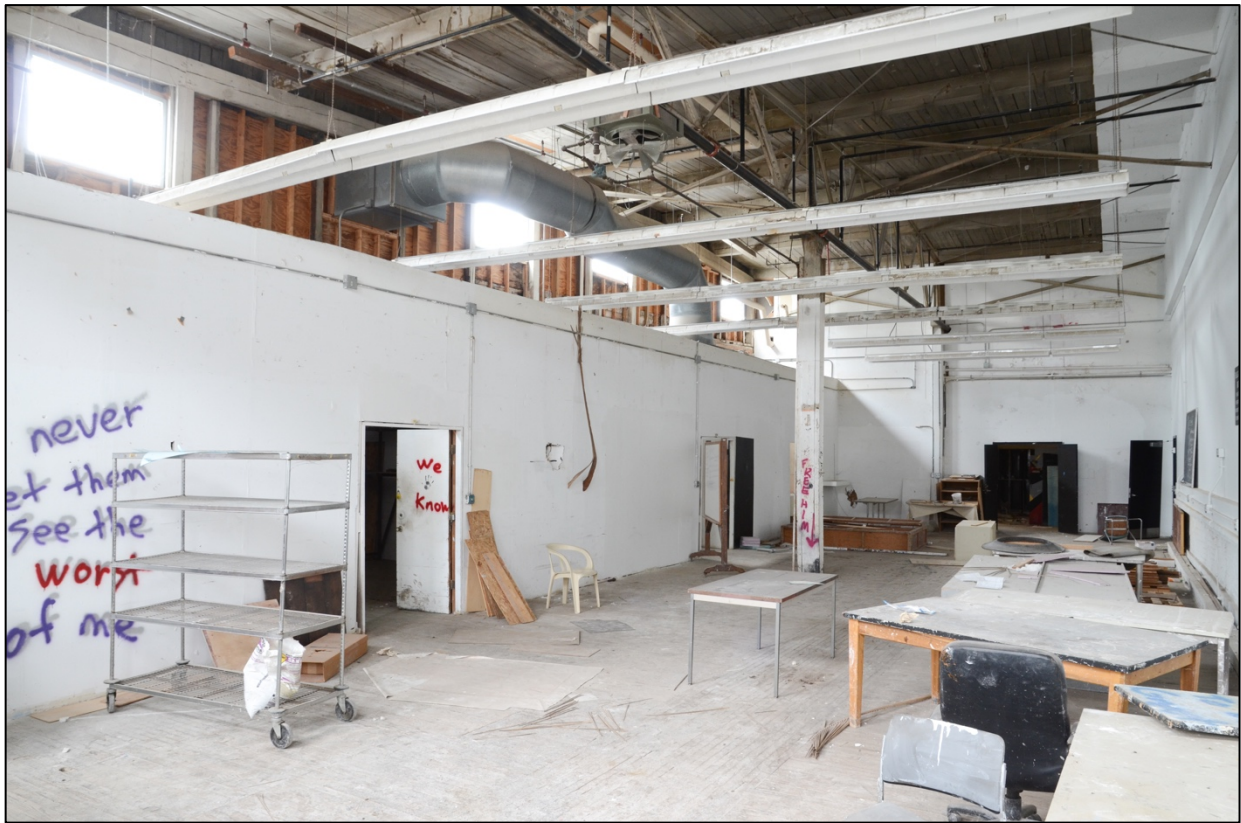
Figure 10. Former cooperage, second floor.

- The narrow room on the second floor immediately west of the warehouse section of the building is the former cooperage, where hogsheads were produced for tobacco storage. This space should be maintained with the associated clerestory windows and given appropriate interpretive panels.

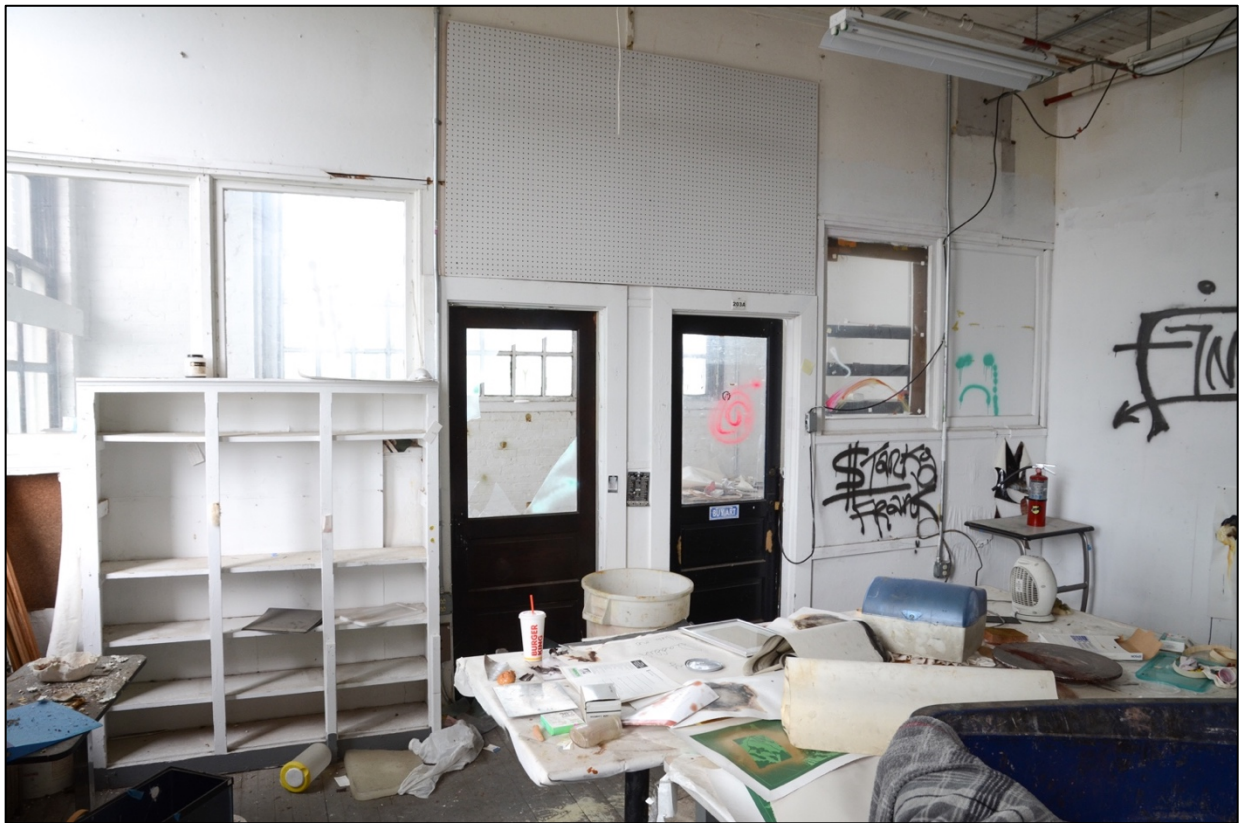
Figure 11. Former offices, second floor, west side of building.

- The wood stair and interior partitions on the second floor at the far west end of the building (closest to the façade) appear to survive from the original offices used by Reynolds Company staff. Some elements are obscured with more recent materials. Careful removal of non-original materials should be undertaken to determine the extent of the surviving interior elements, which appear to consist principally of beadboard wainscoting, hardwood doors (most of which have windows of various sizes), and decorative trimwork. If the original partitions and finishes are largely intact, these should be retained and incorporated into the new design if doing so will not adversely affect programing and space allocations.

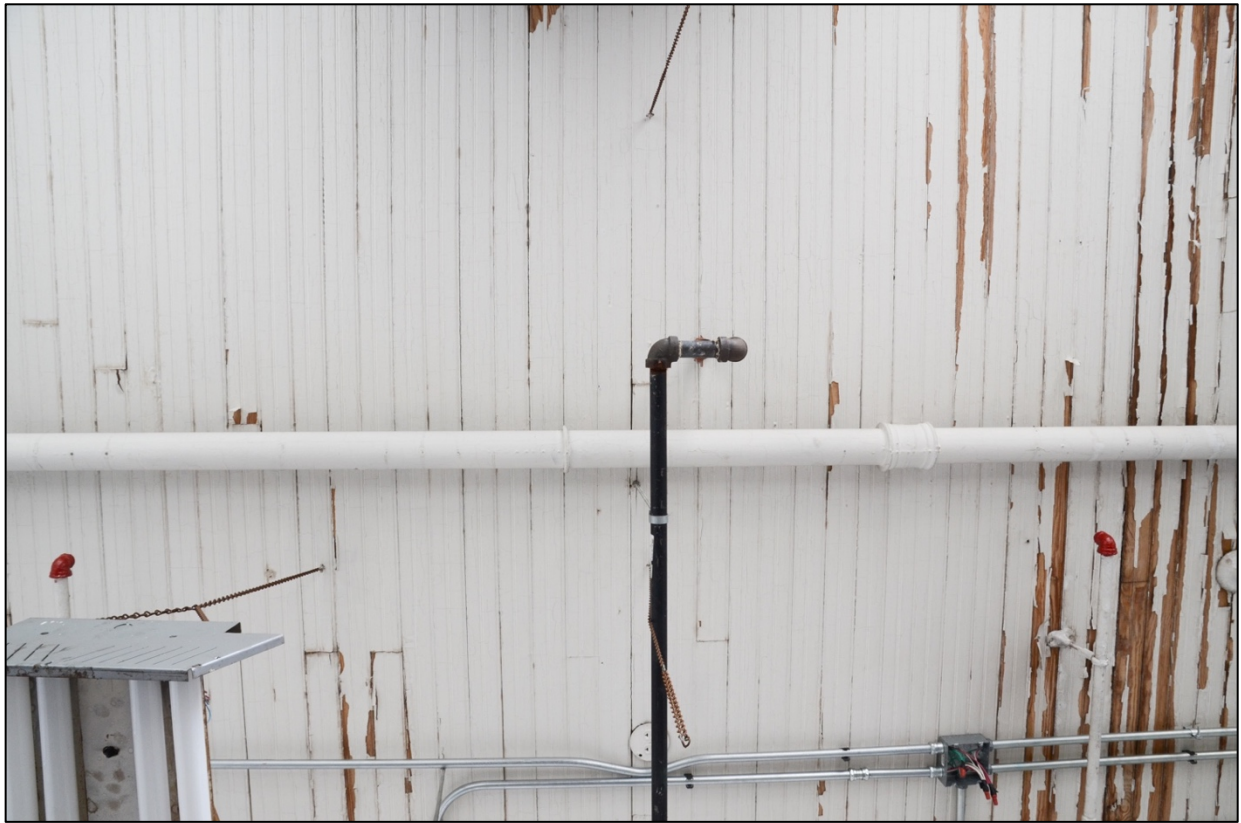
Figure 12. Beadboard detail, former offices.

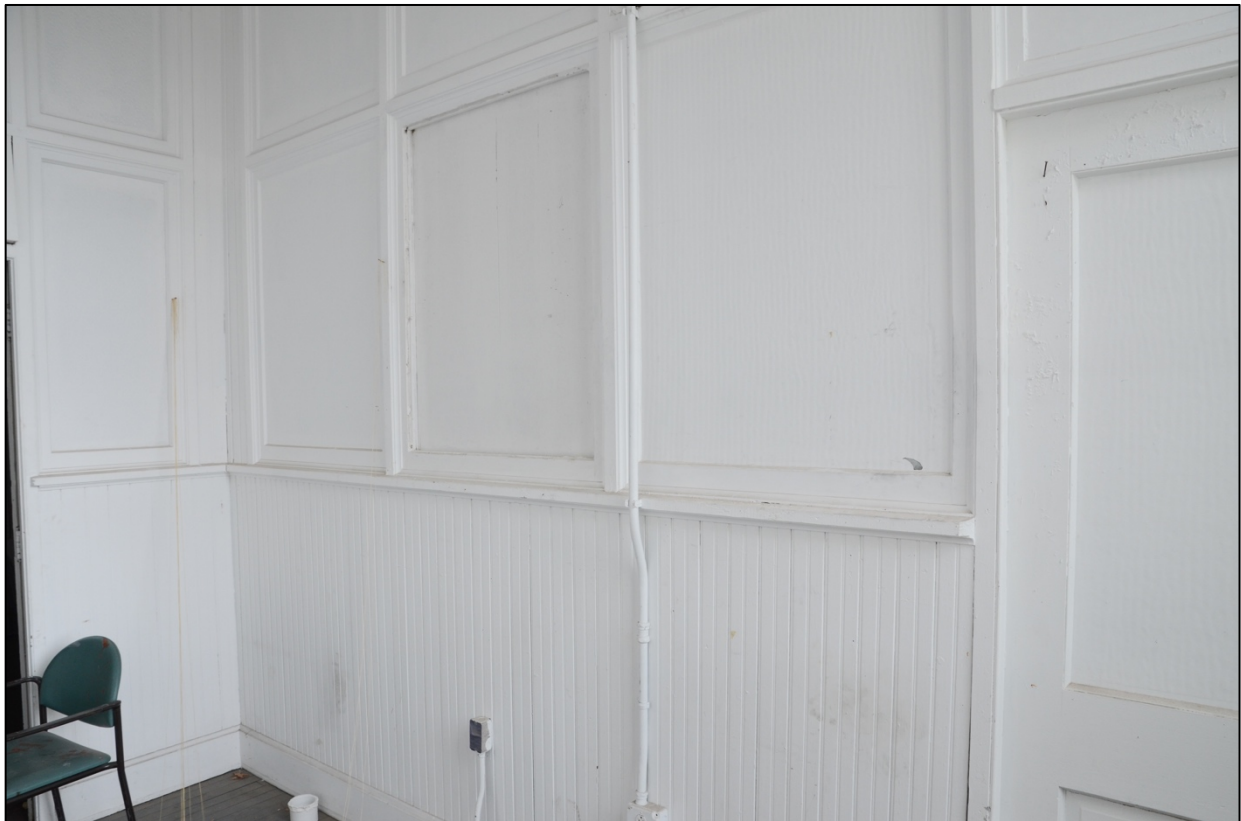
Figure 13. Trimwork, former offices.

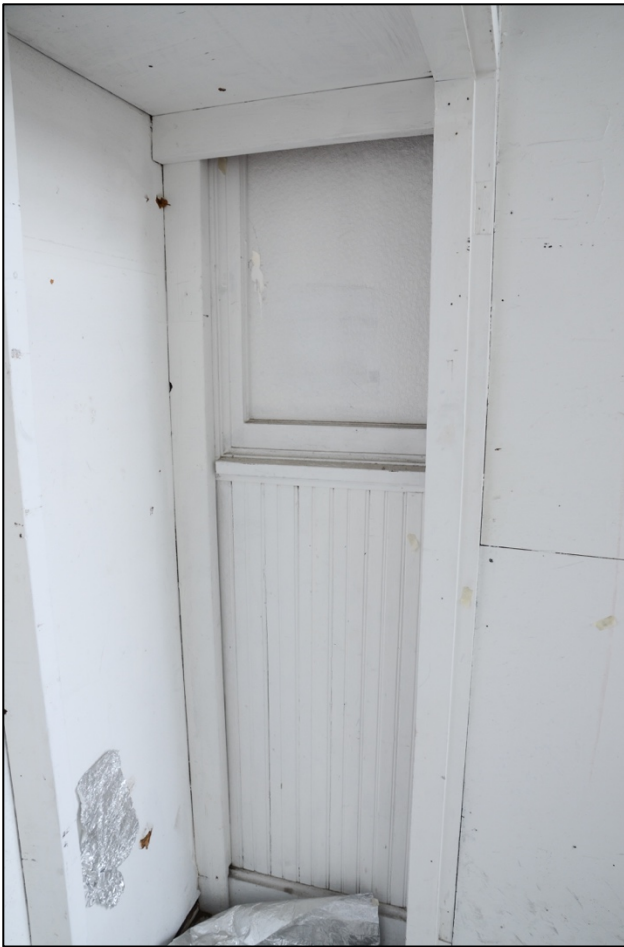
Figure. 14. Beadboard, former offices.

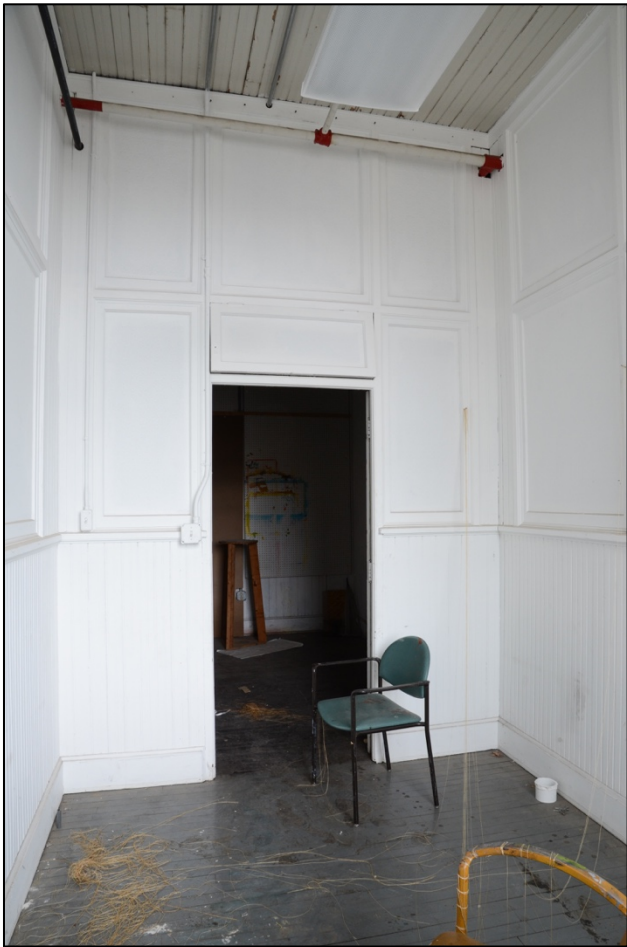
Figure 15. Trimwork, former offices.

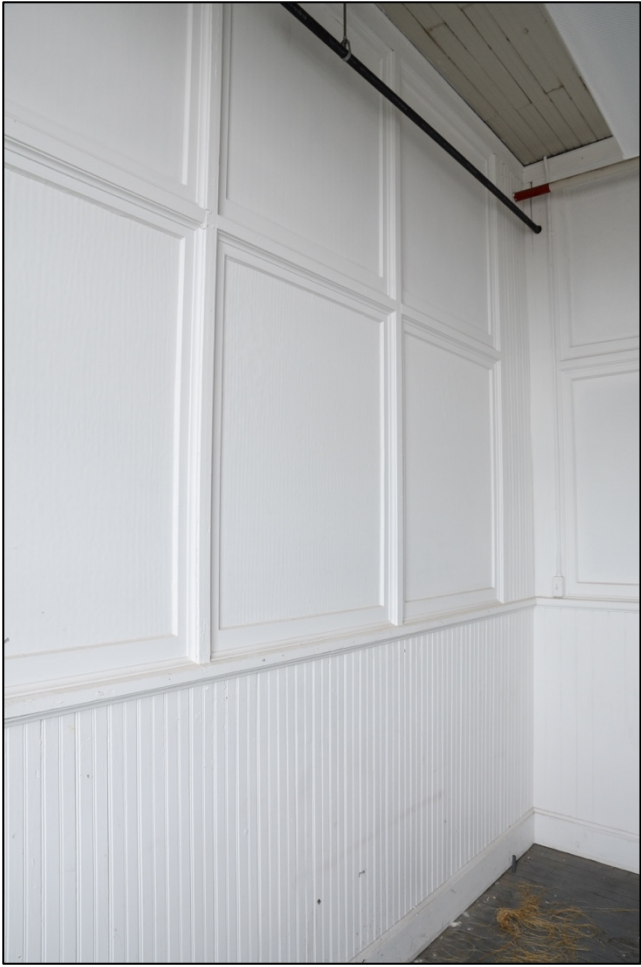
Figure 16. Trimwork, former offices.
