Reynolds Conditions Assessment

The conditions assessment was completed by Travis Rose and Master of Historic Preservation student: Jack Galle.
Material conservation assessments were completed by the Fall 2022 students of HP 252.

From August to December of 2022, a conservation conditions assessment was completed for the Reynolds Building. The task was to document the building's condition prior to a major rehabilitation of the building. Students were instructed to identify maintenance needs, instances of unusual wear or deterioration and provide conservation recommendations of historic structural systems, and important architectural features as needed. The Reynolds Building was documented, material conditions were assessed, and critical deterioration was recorded; important structural systems and character-defining elements were analyzed in detail. Building condition assessments were recorded in a spreadsheet, with accompanied floorplans to identify deterioration locations.¹

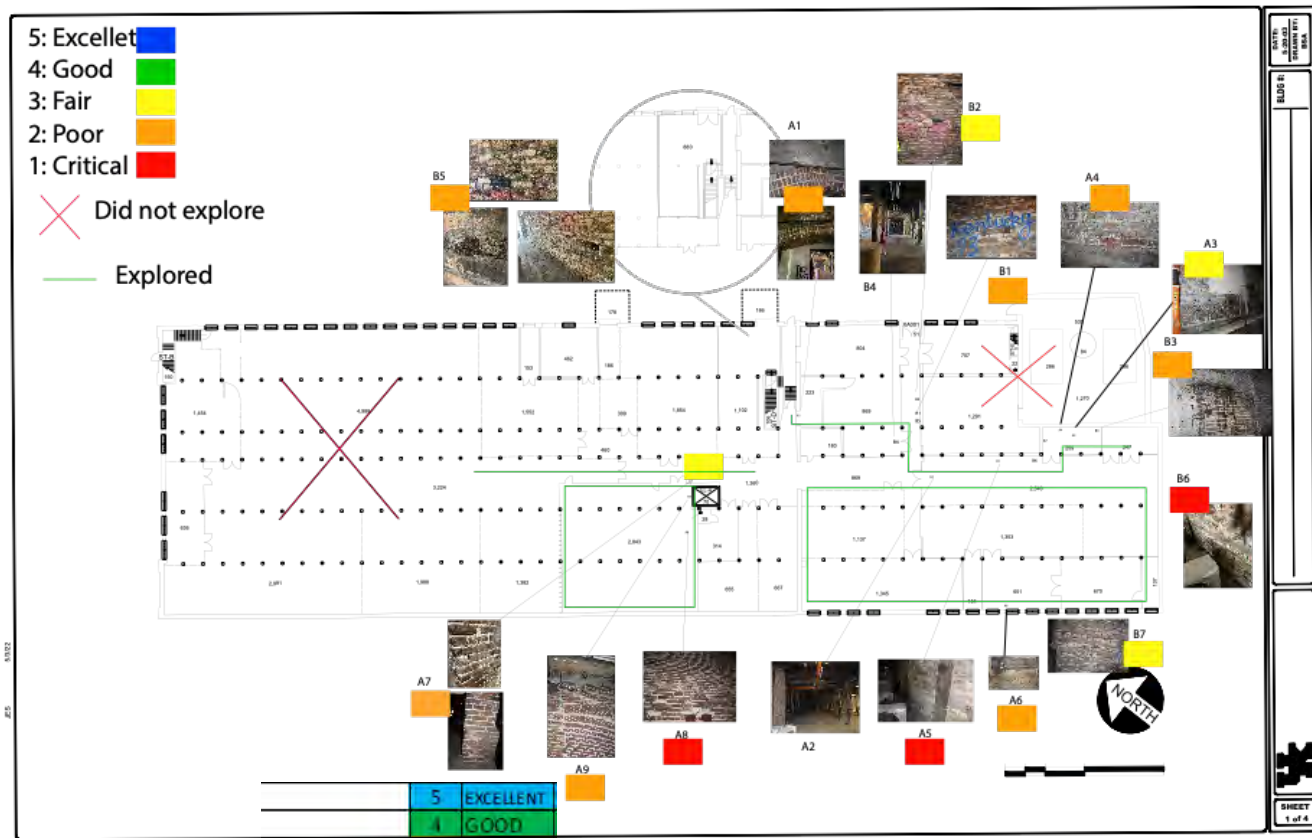
FLOOR PLAN - BASEMENT LEVEL

5	4	3	2	1	
Image 6u.	Brick	X						Open area left wall with new brick laid inside, good condition.
Image 1dl.	Brick							X Large area with bricks not intact with wall flat soever. No mortar in between.
Image 6v.	Brick				X			Mass vegetation growing along side of building wall

The condition of the brick in the basement of Reynolds varied throughout the space. Most of the bricks were in fair to good condition, however, on the interior wall perpendicular to where the large barn door was, the wall had started to fall in because the bricks had begun to crumble.

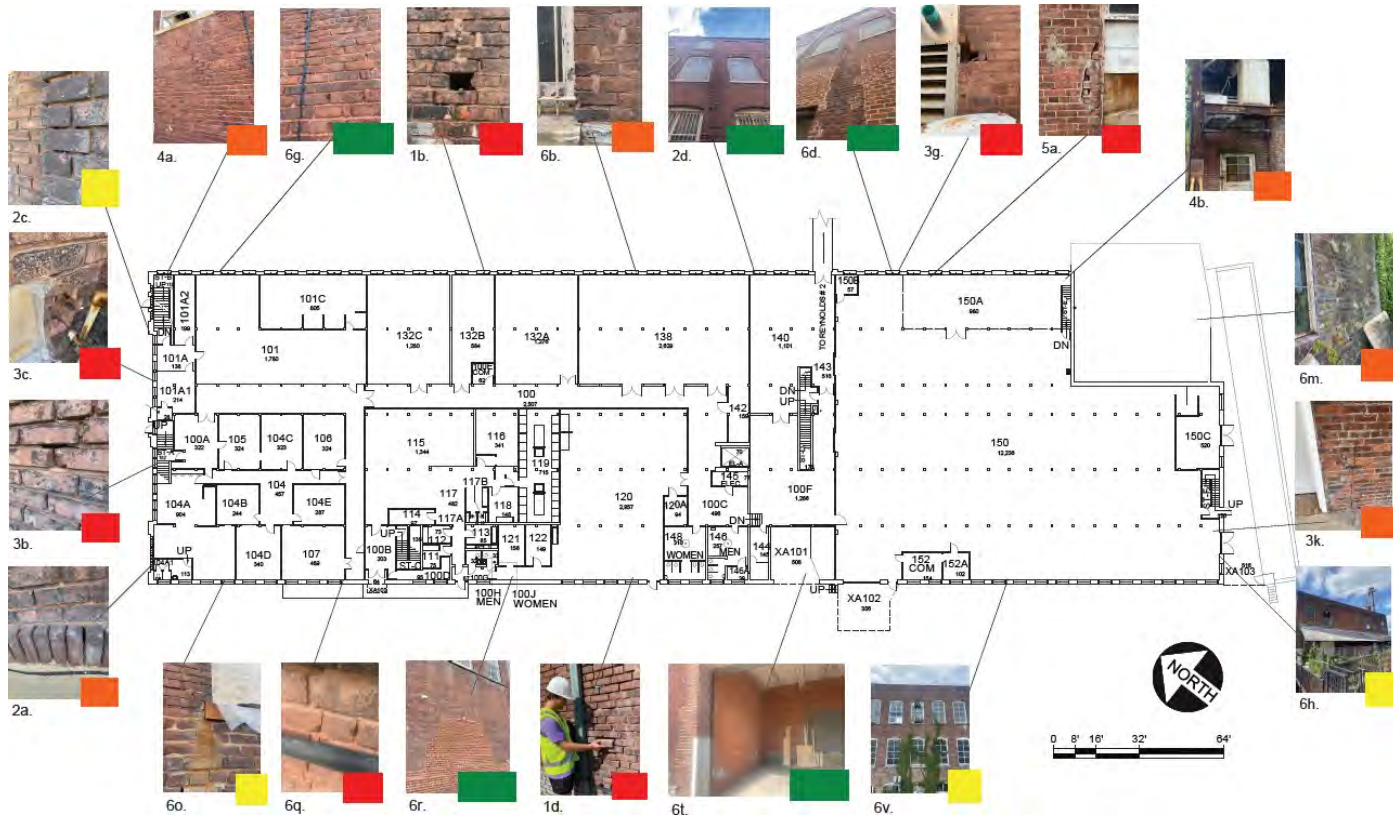
FLOOR PLAN - EXTERIOR

The exterior of the building had the most damage and issues in regard to the conditions of architectural ceramics. In comparison to other areas of the building, what was most prominent were large cracks and breakage of bricks, as well as bricks completely missing from the wall. Also, where external materials interacted with the bricks, like wall support clamps and windowsills, is where many issues like discoloration and cracks occurred. Many attempts to fix issues like missing mortar included patches of cementitious material all around the exterior of the building. Overall, the mass amounts of brick used within the Reynolds building had various conditions from fair to fatal with a wide variety of issues relating to the brick.

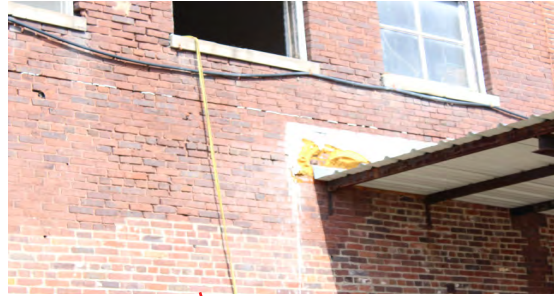
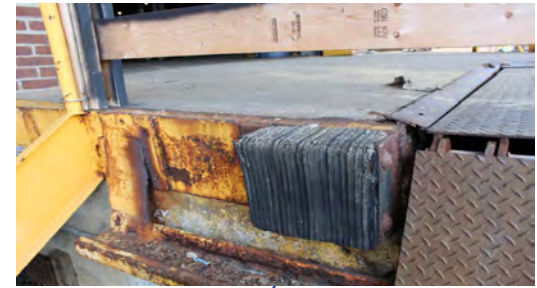
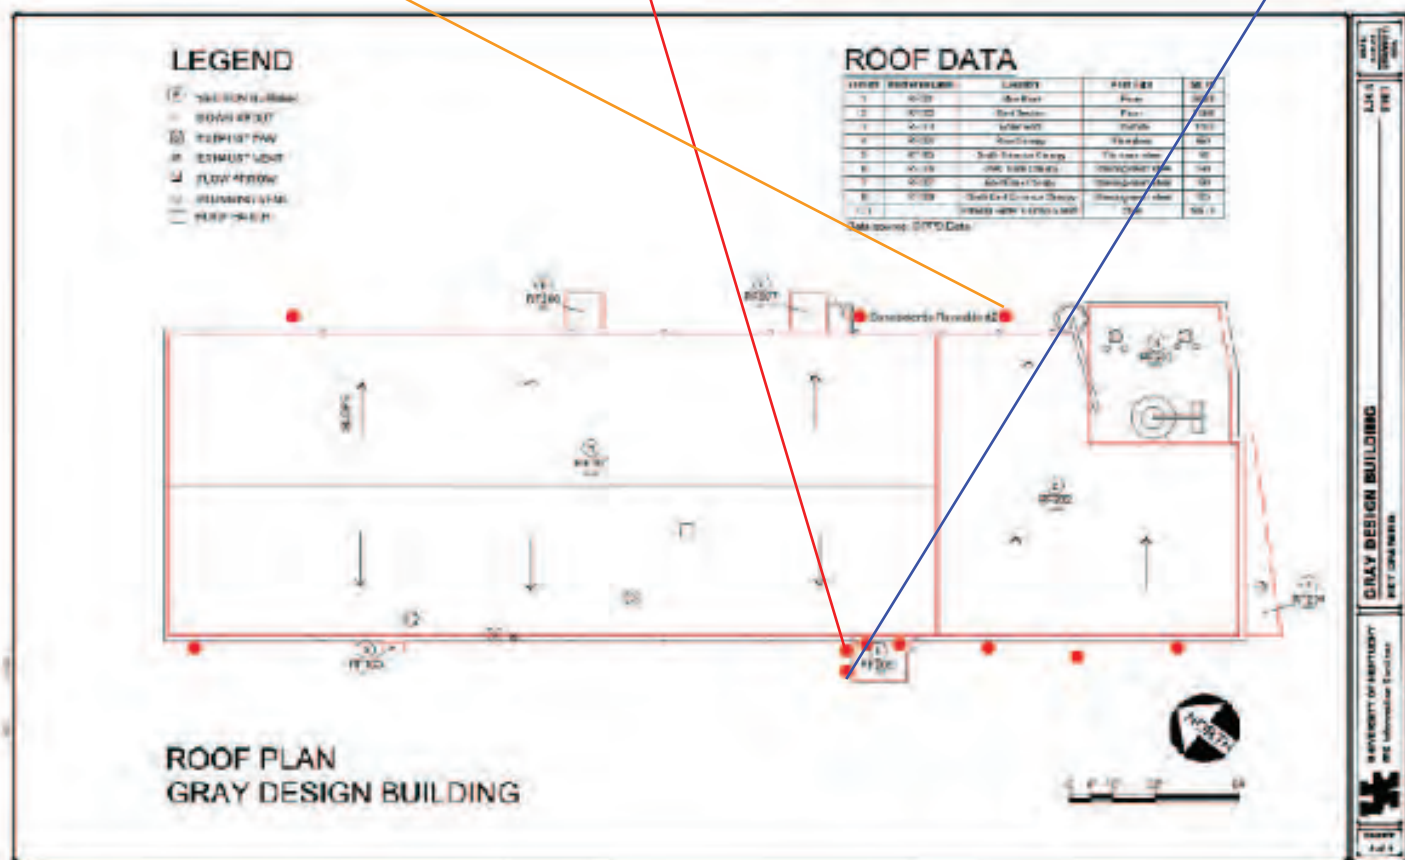
Images taken of the exterior of the Reynolds Building on 9-01-2022 and synthetic material samples include exposed insulation at plumbing penetrations and around exits, electric and utility cables and wiring fastened to the façades, pipes, exterior light fixtures, security cameras, signage, and apparent rubber finishes on a shed and bumpers at loading area.

Material	5	4	3	2	1	Notes
Exterior								
	18	Plastic Windows				X		Varying quality, some more damaged than others
	19	Plastic Light Fixtures		X				
	20	Insulation					X	There are multiple areas.
	21	Rubber Wire Casing		X				
	22	Insulating Pipe Bumpers			X			Full length
	23	Water Pipe House cover		X				Outside weathering

Particularly in the case of the mechanical, electrical, and plumbing equipment, the materials we found in the building that were in good condition could be repurposed for the renovation. For the materials in poor condition, it would be our recommendation to replace them with natural alternatives and recycle the waste if possible.

We recommend laboratory testing for the existing insulation for potential asbestos hazard.
